Leicester Primary School  
170 Paxton Street  
Leicester, MA 01524

AHERA Three-Year Reinspection

April 2019

AHERA 3-Year Re-Inspection

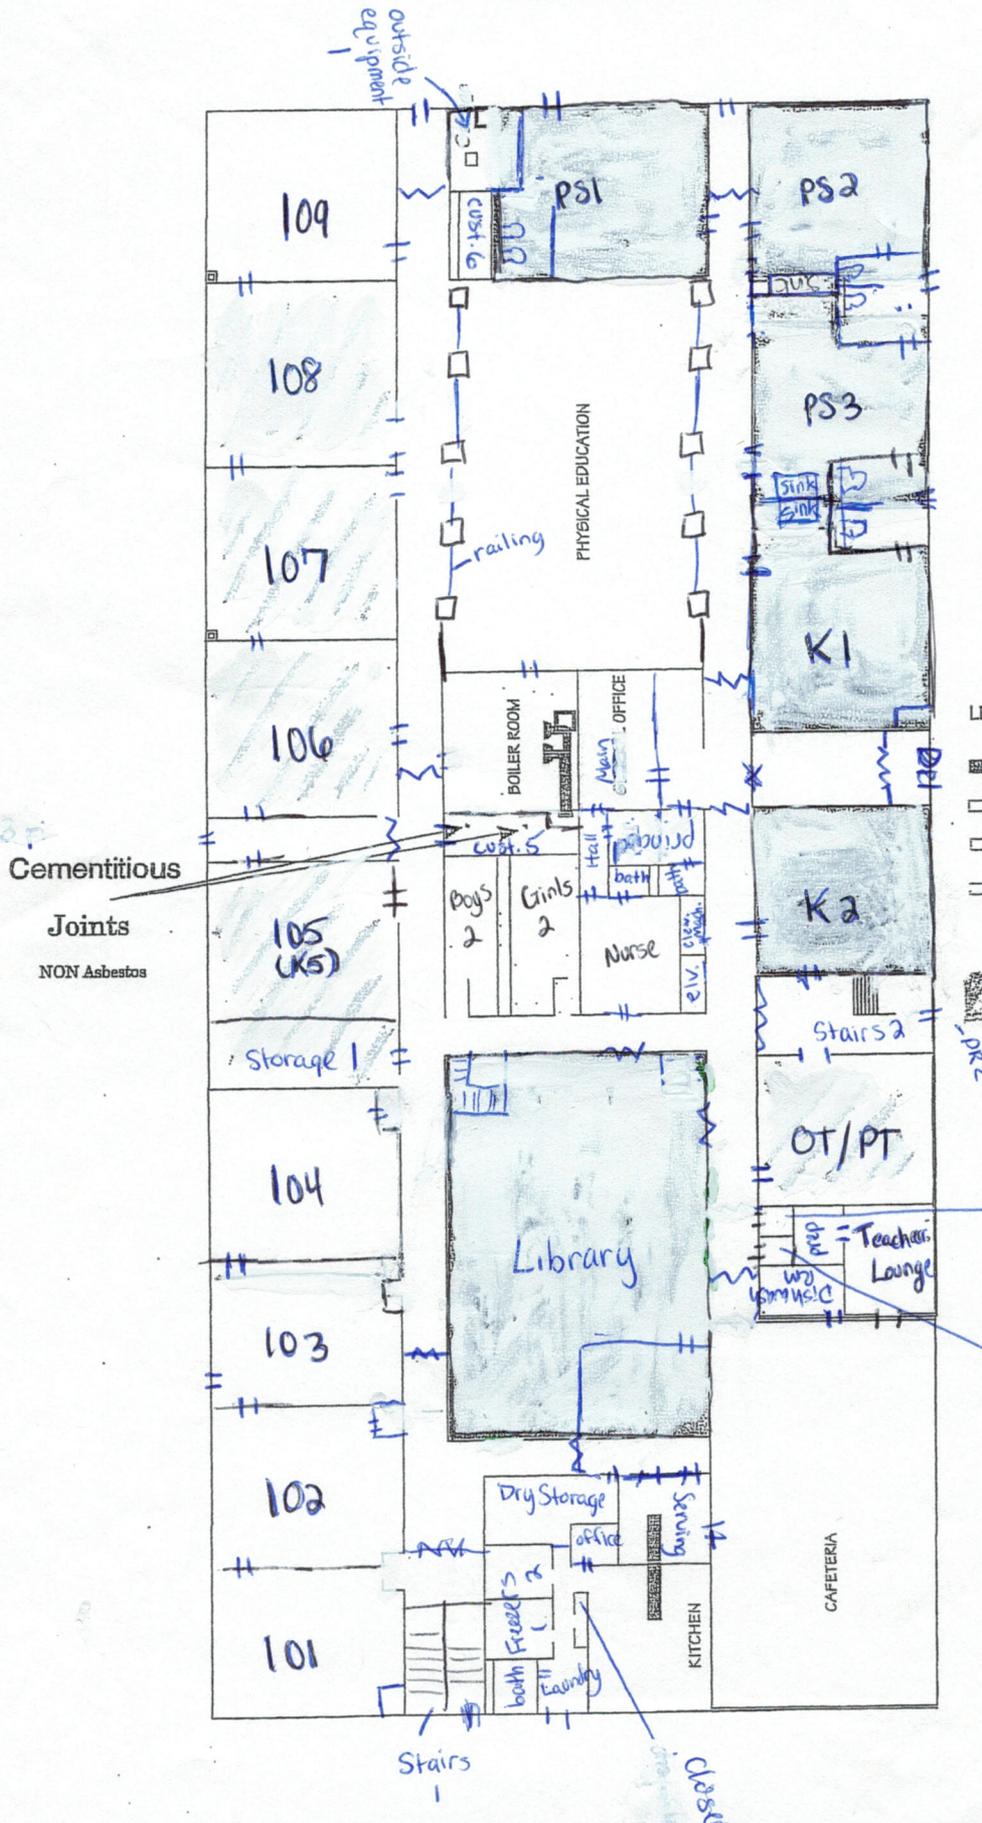
# Master 1st Floor

**FIRST FLOOR PLAN  
 AUGUST 1, 1995**

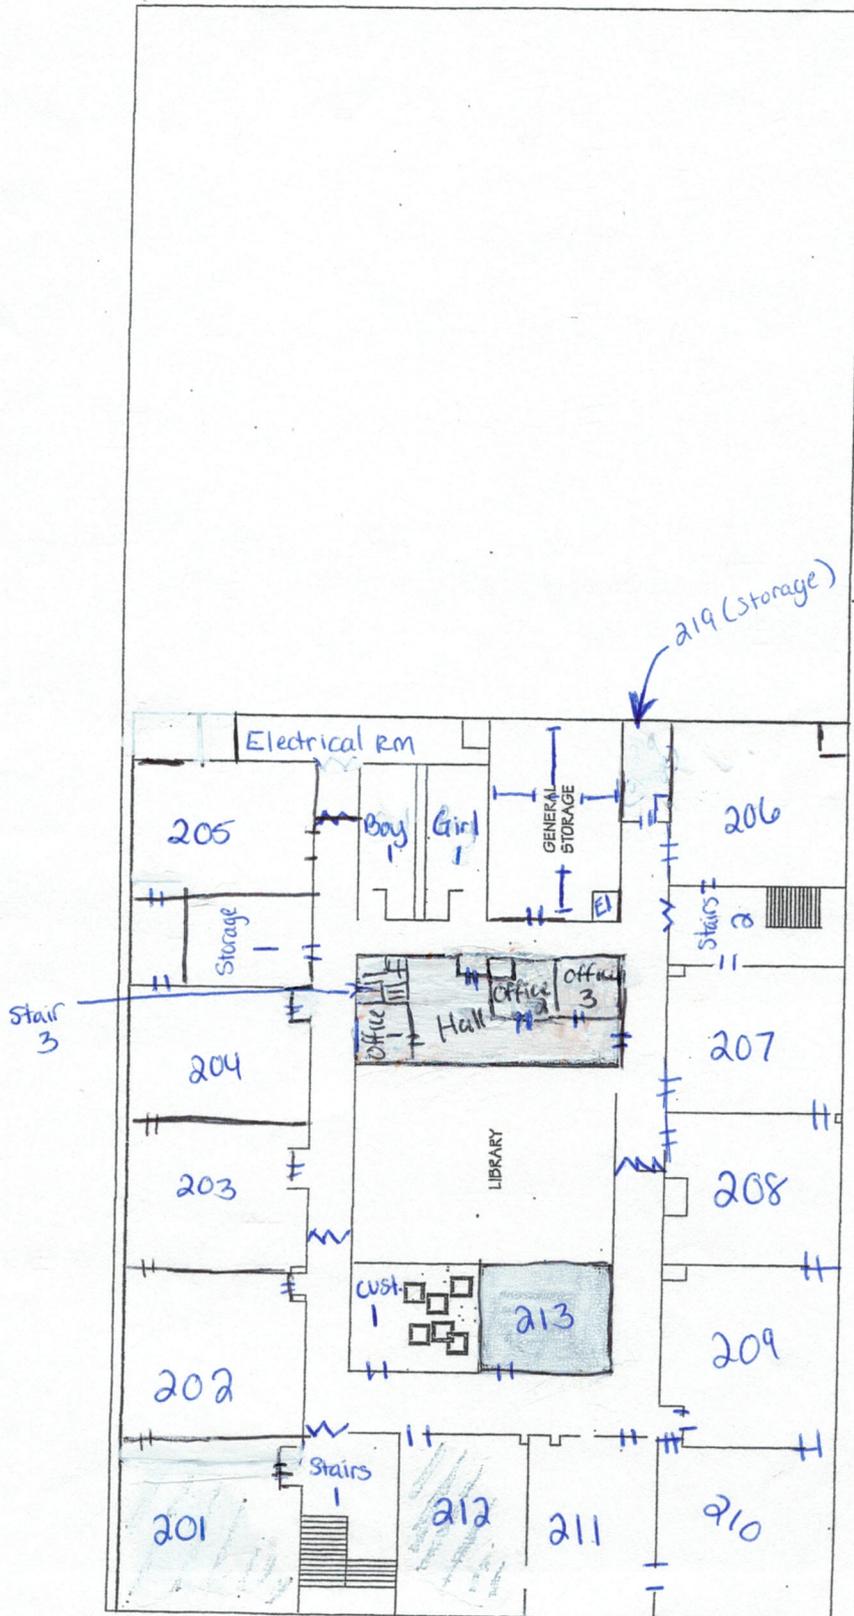
# Master 2nd Floor

Architectural Drawings specify all floor tiles used in construction to be vinyl asbestos

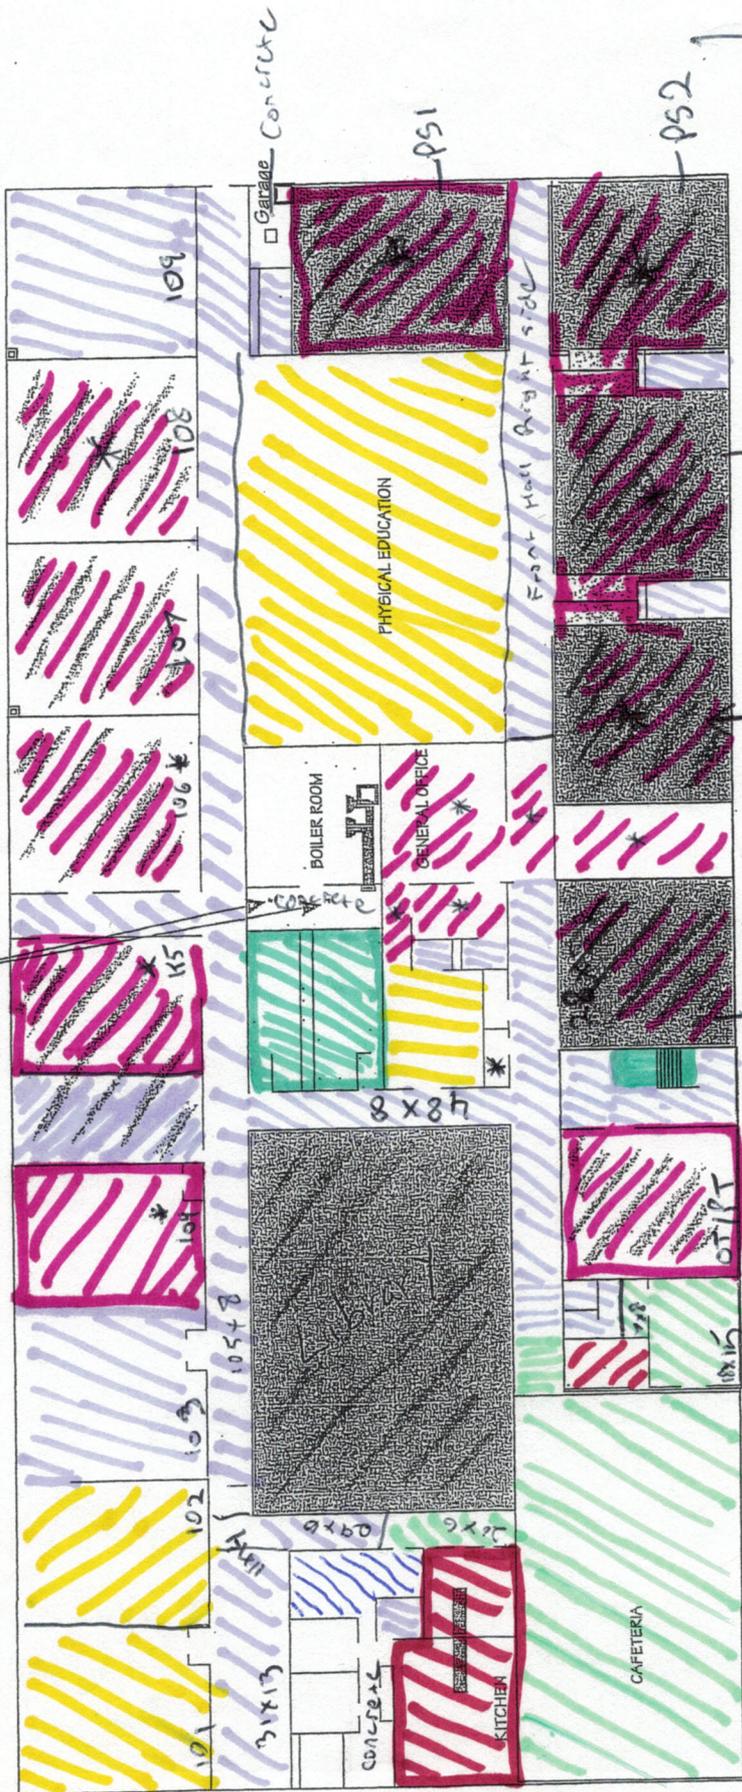
Flooring  
Tiles /  
Floor

- FRIABLE TROWELED ON ASBESTOS
  - ASBESTOS CONTAINING FLOOR TILES
  - CARPET
  - CONCRETE/TILE
  - VIBRATION DAMPER
- V.I.A.T under Carpet*

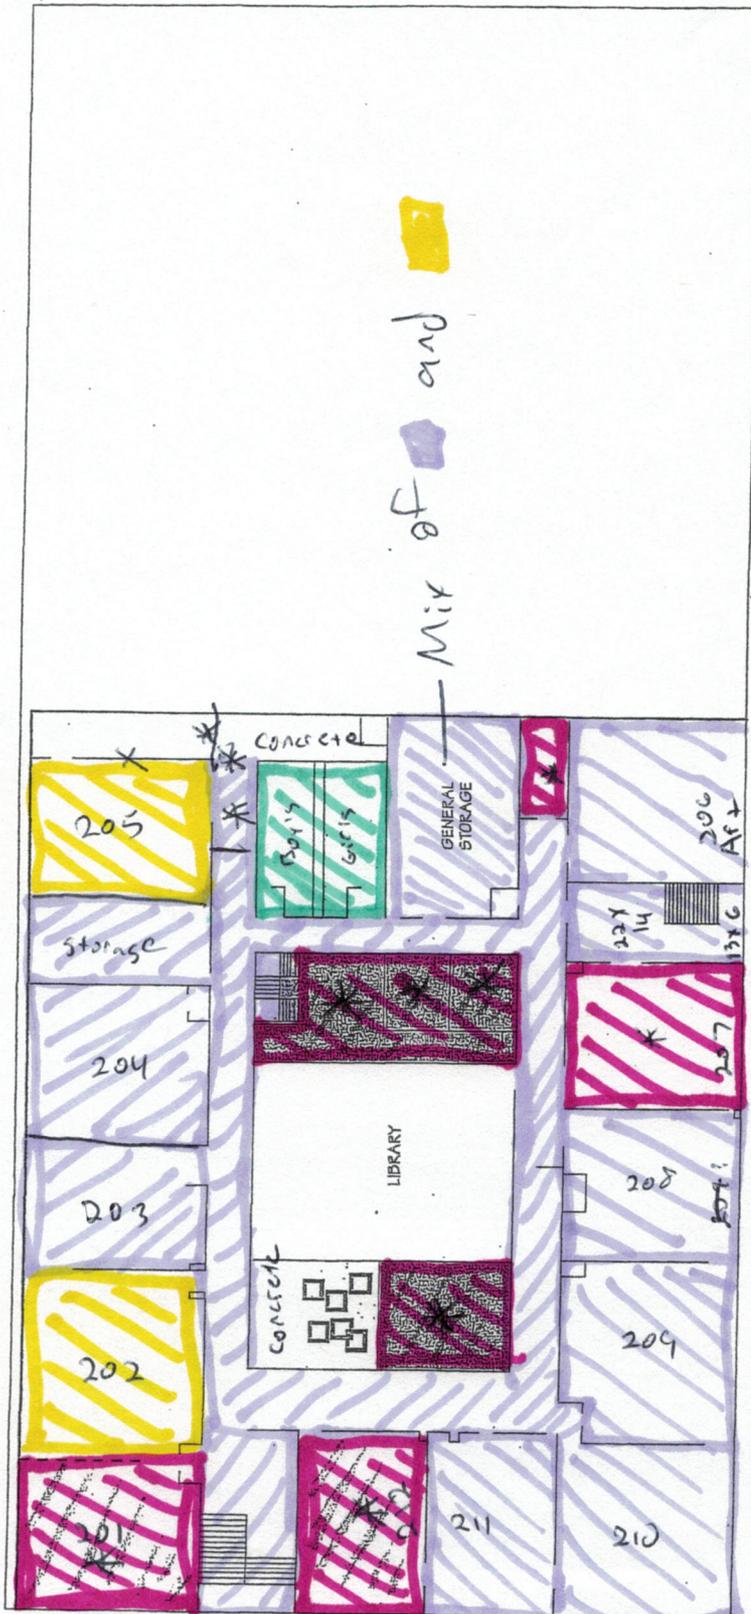
# Flooring 2nd floor

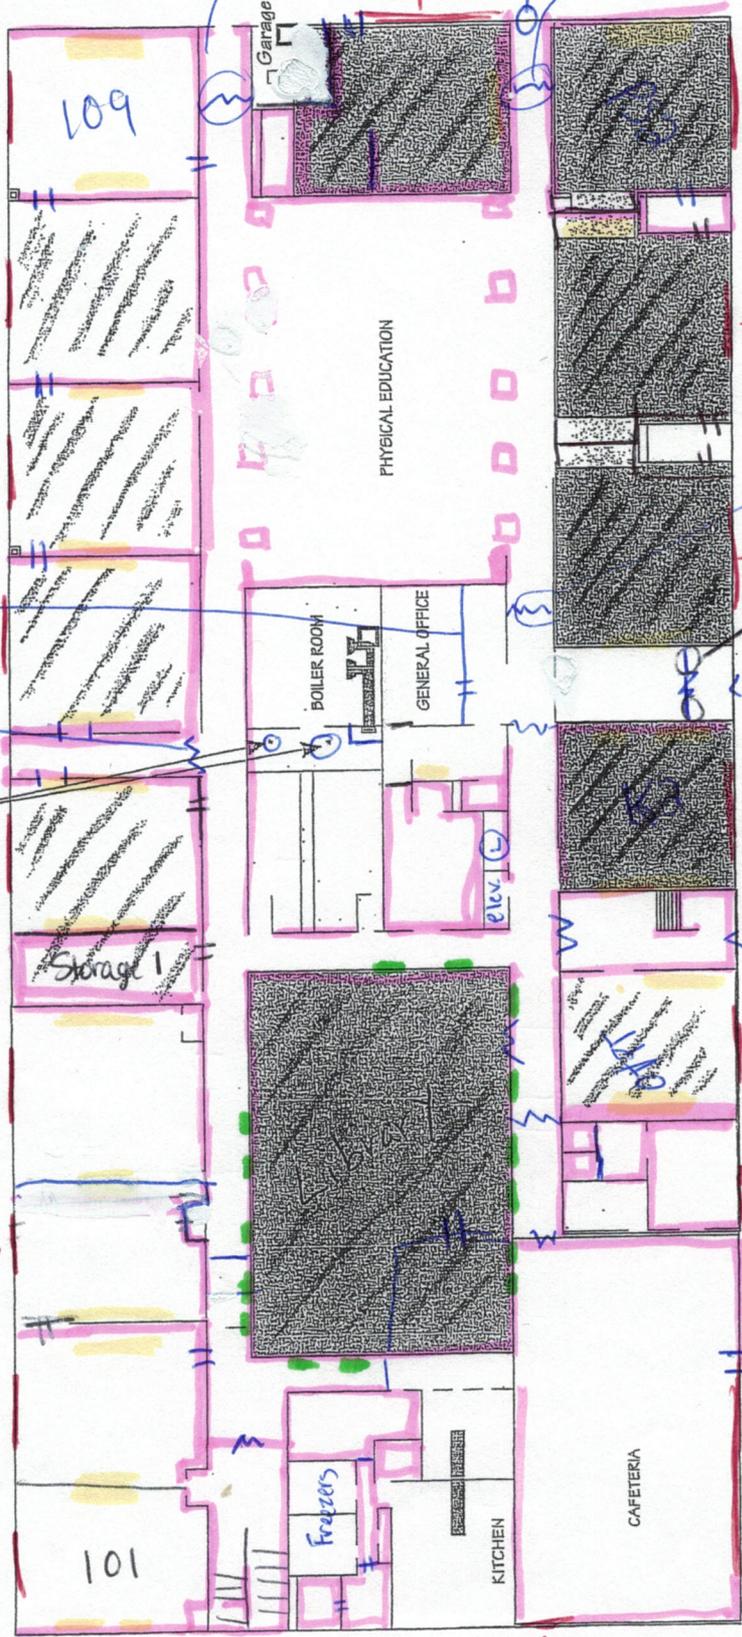
Misc. materials

1x3 on double  
1x3 on ext  
1x3 on double

4x4 panels (x5)  
1x3 panel  
Cementitious Joints  
3 joints/fittings  
NON Asbestos!

LEICESTER PRIMARY SCHOOL  
LEICESTER MA 01524  
FIRST FLOOR PLAN  
AUGUST 1, 1995

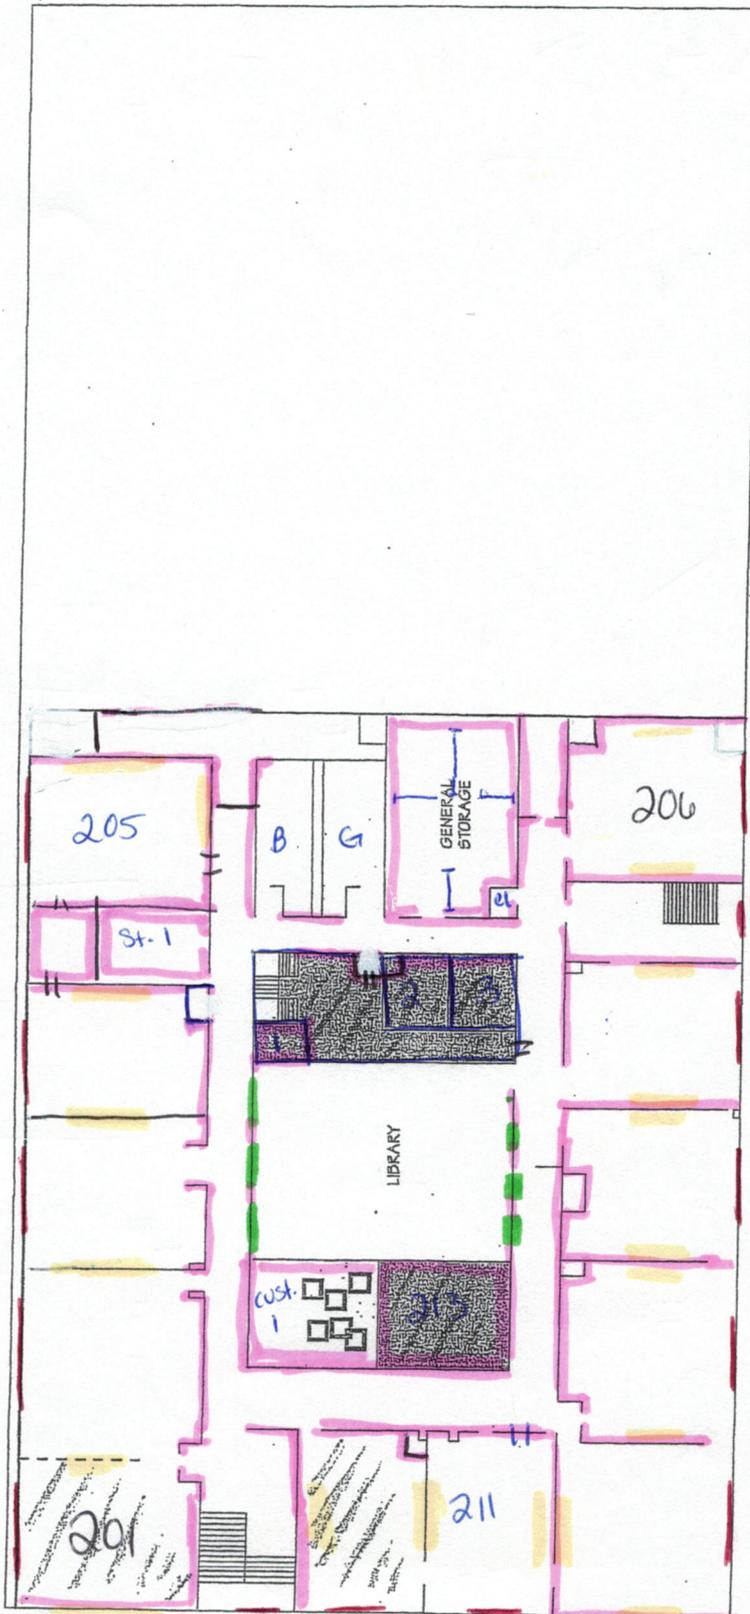
Misc. materials

LEICESTER PRIMARY SCHOOL  
LEICESTER MA 01524  
SECOND FLOOR PLAN  
AUGUST 1, 1995

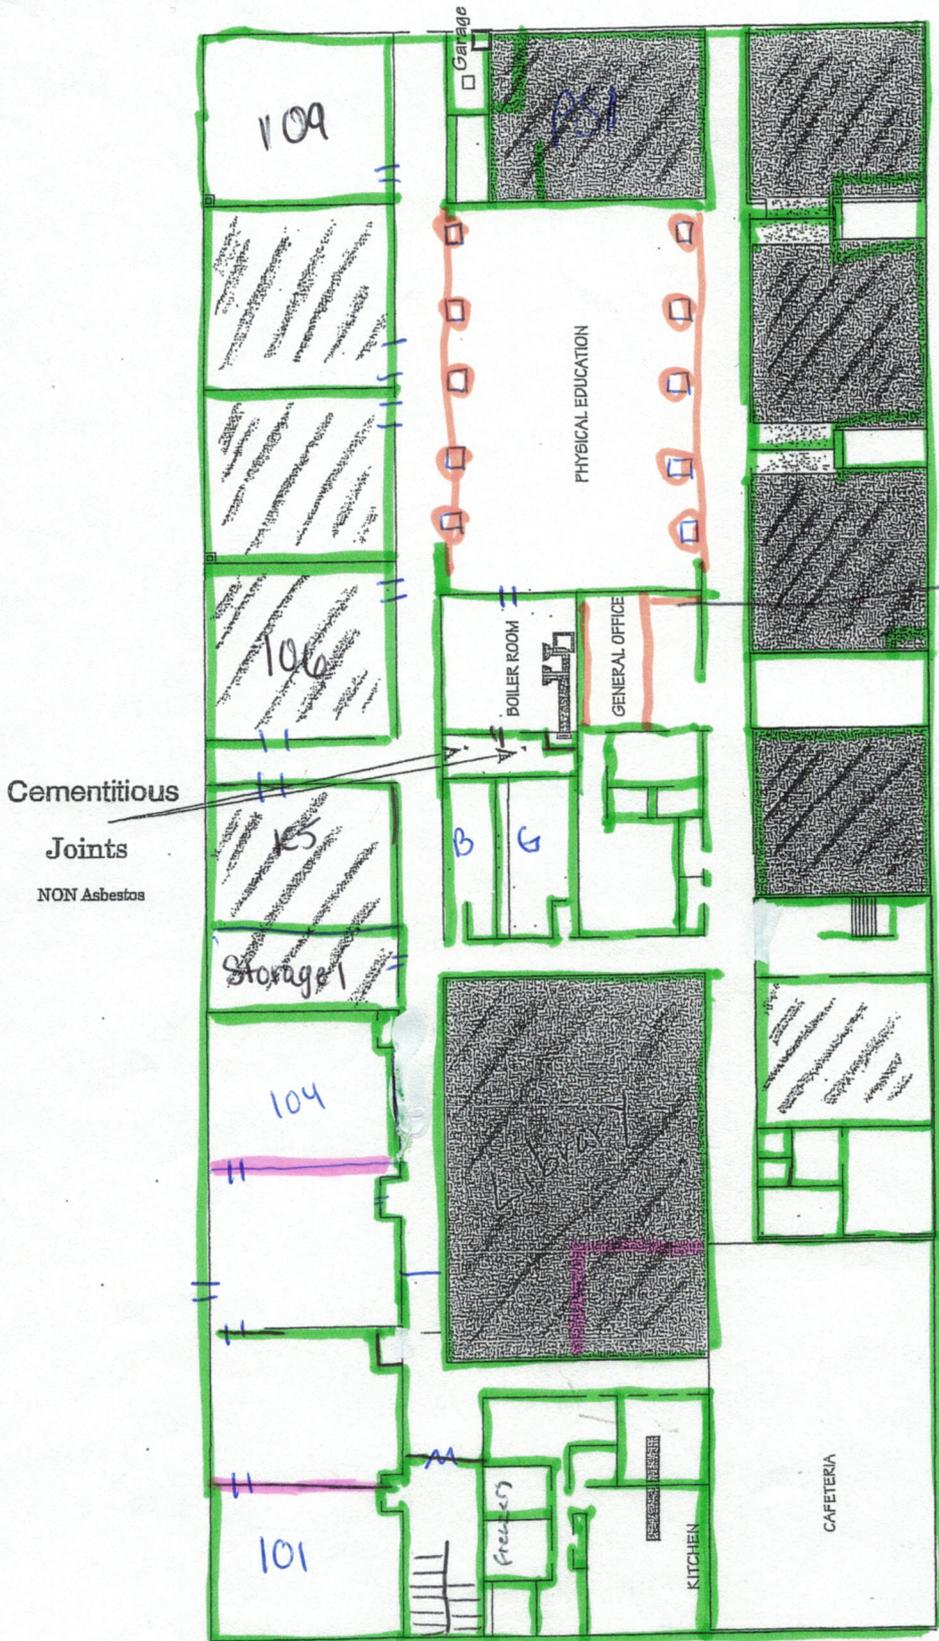
# Walls

SR soff. +  
SR ~~soff.~~ out

**LEICESTER PRIMARY SCHOOL  
LEICESTER MA 01524  
FIRST FLOOR PLAN  
AUGUST 1, 1985**

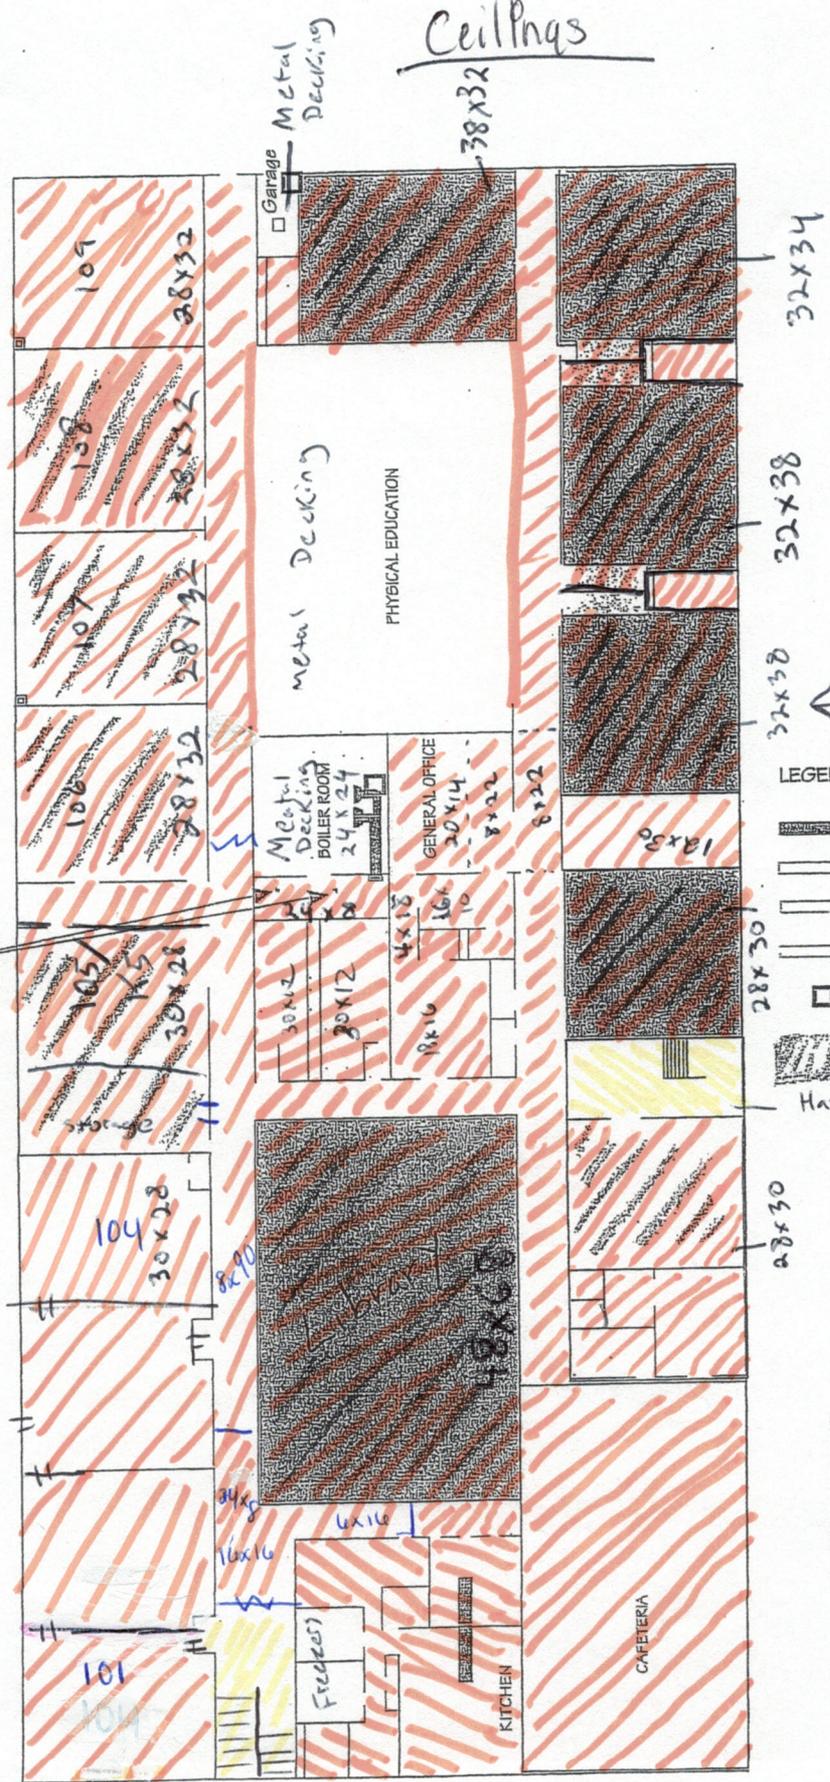
Ceilings

Cementitious  
 Joints  
 NON Asbestos

- FRIABLE TROWELED ON ASBESTOS
  - ASBESTOS CONTAINING FLOOR TILES
  - CARPET
  - CONCRETE/TILE
  - VIBRATION DAMPER
  - Hard Ceiling
- V.I.A.T under Carpet

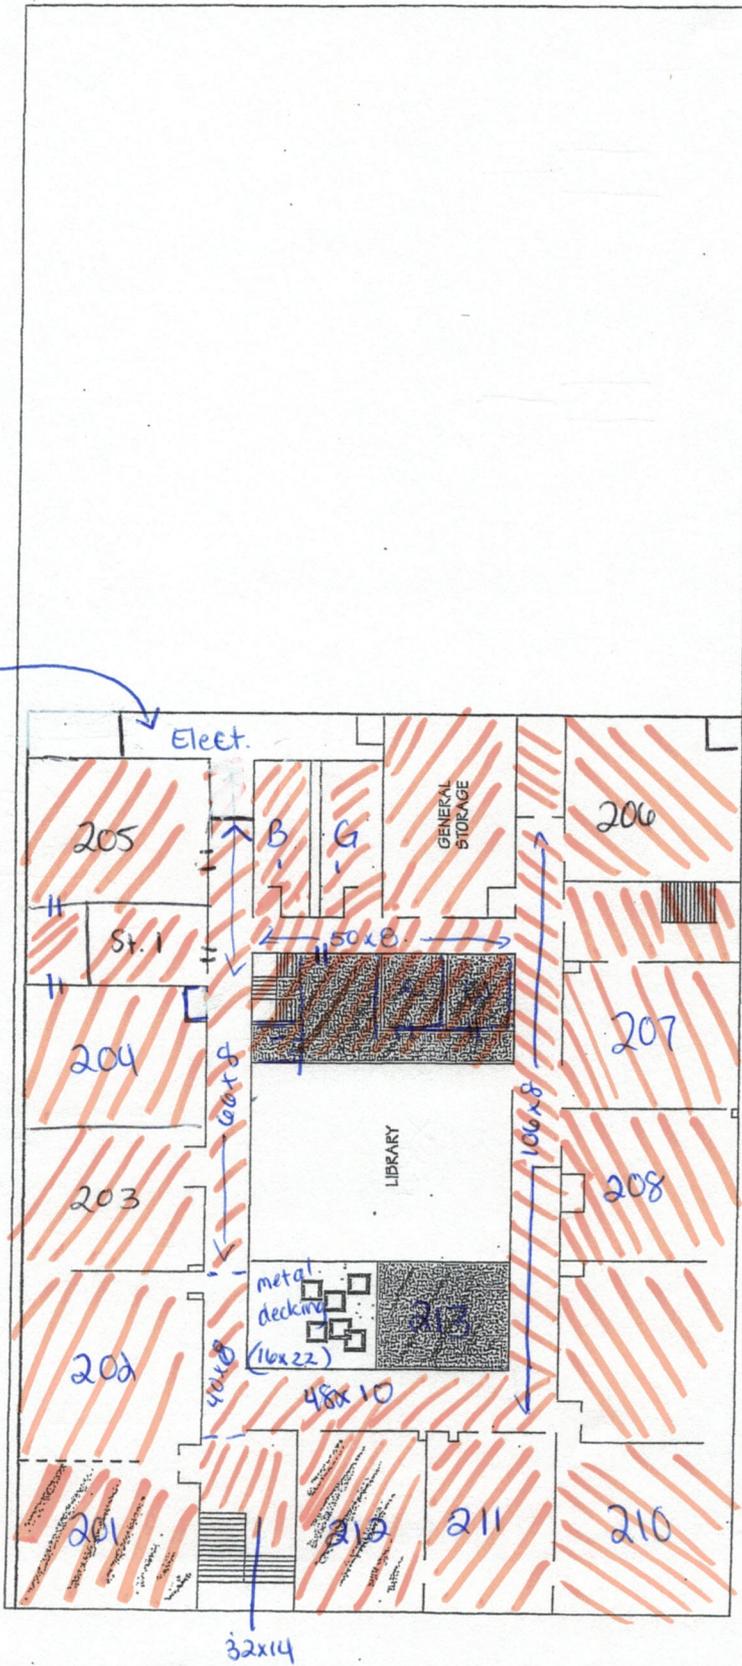
# Ceilings

metal decking
